U.S. Fire Administration/Technical Report Series

# Floor Collapse Claims Two Firefighters

Pittston, Pennsylvania

USFA-TR-073/March 1993

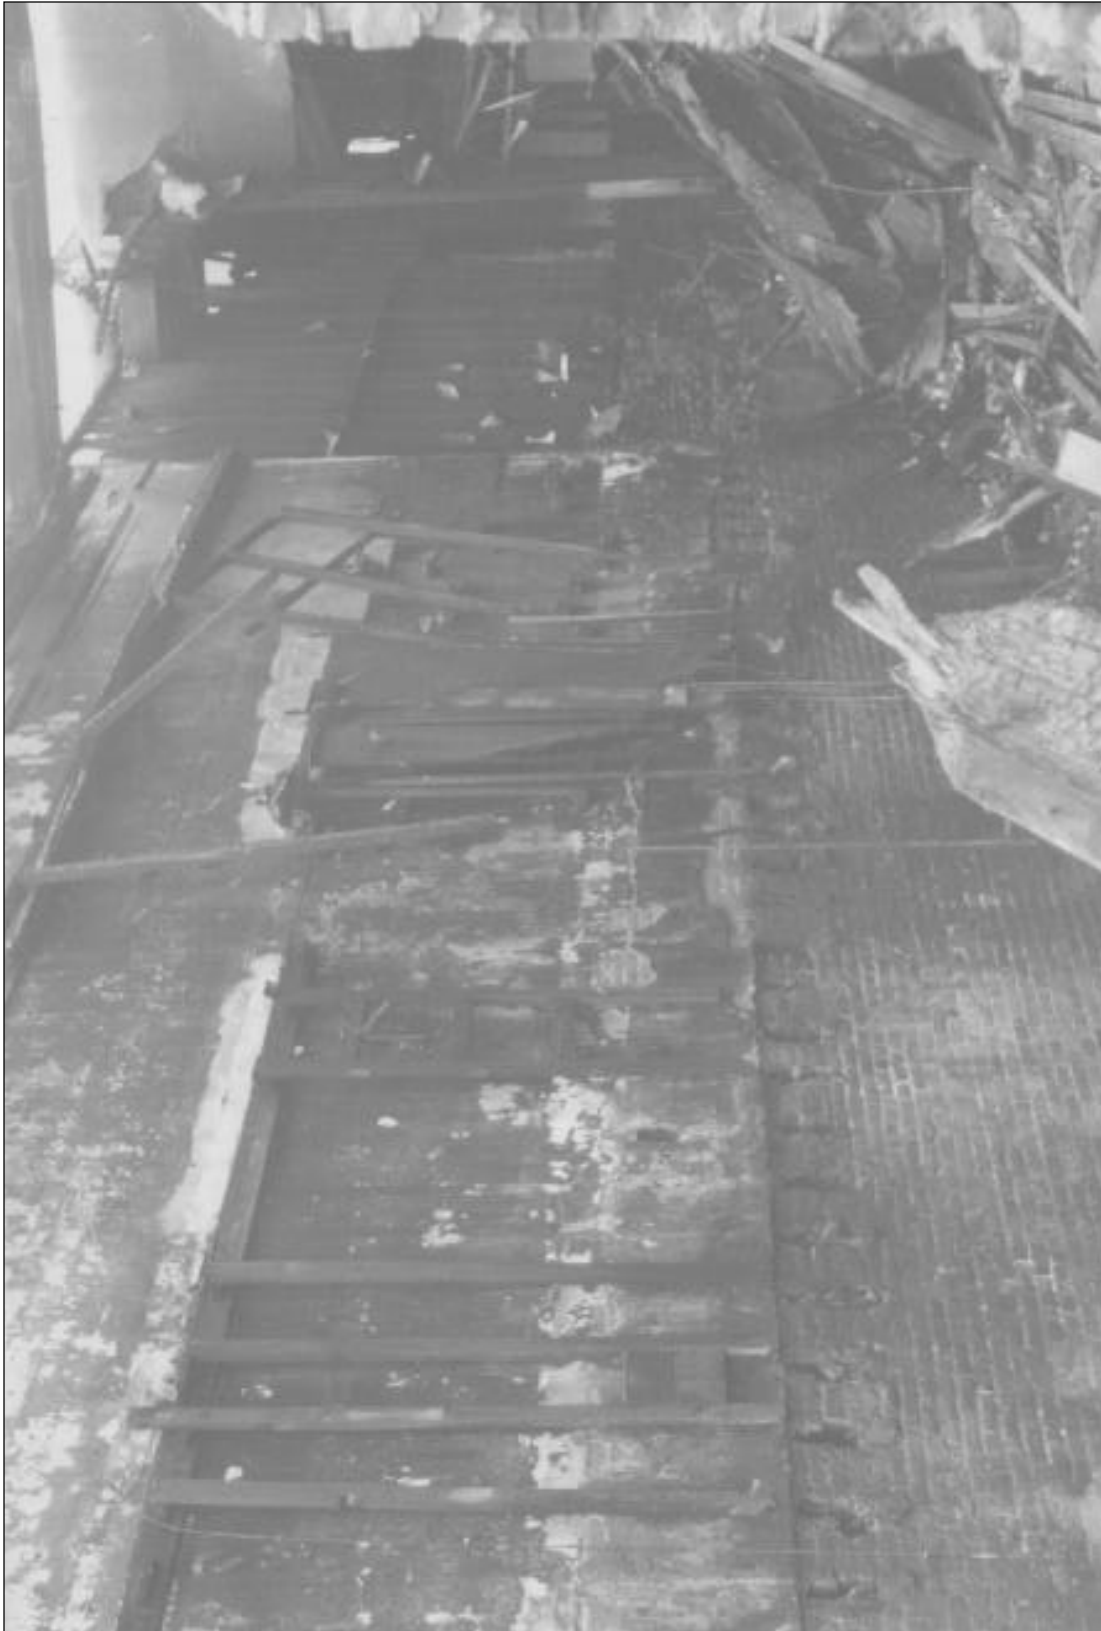
**The wall of the front portion of the stationary store remains standing, although the interior is destroyed and the roof has collapsed.**

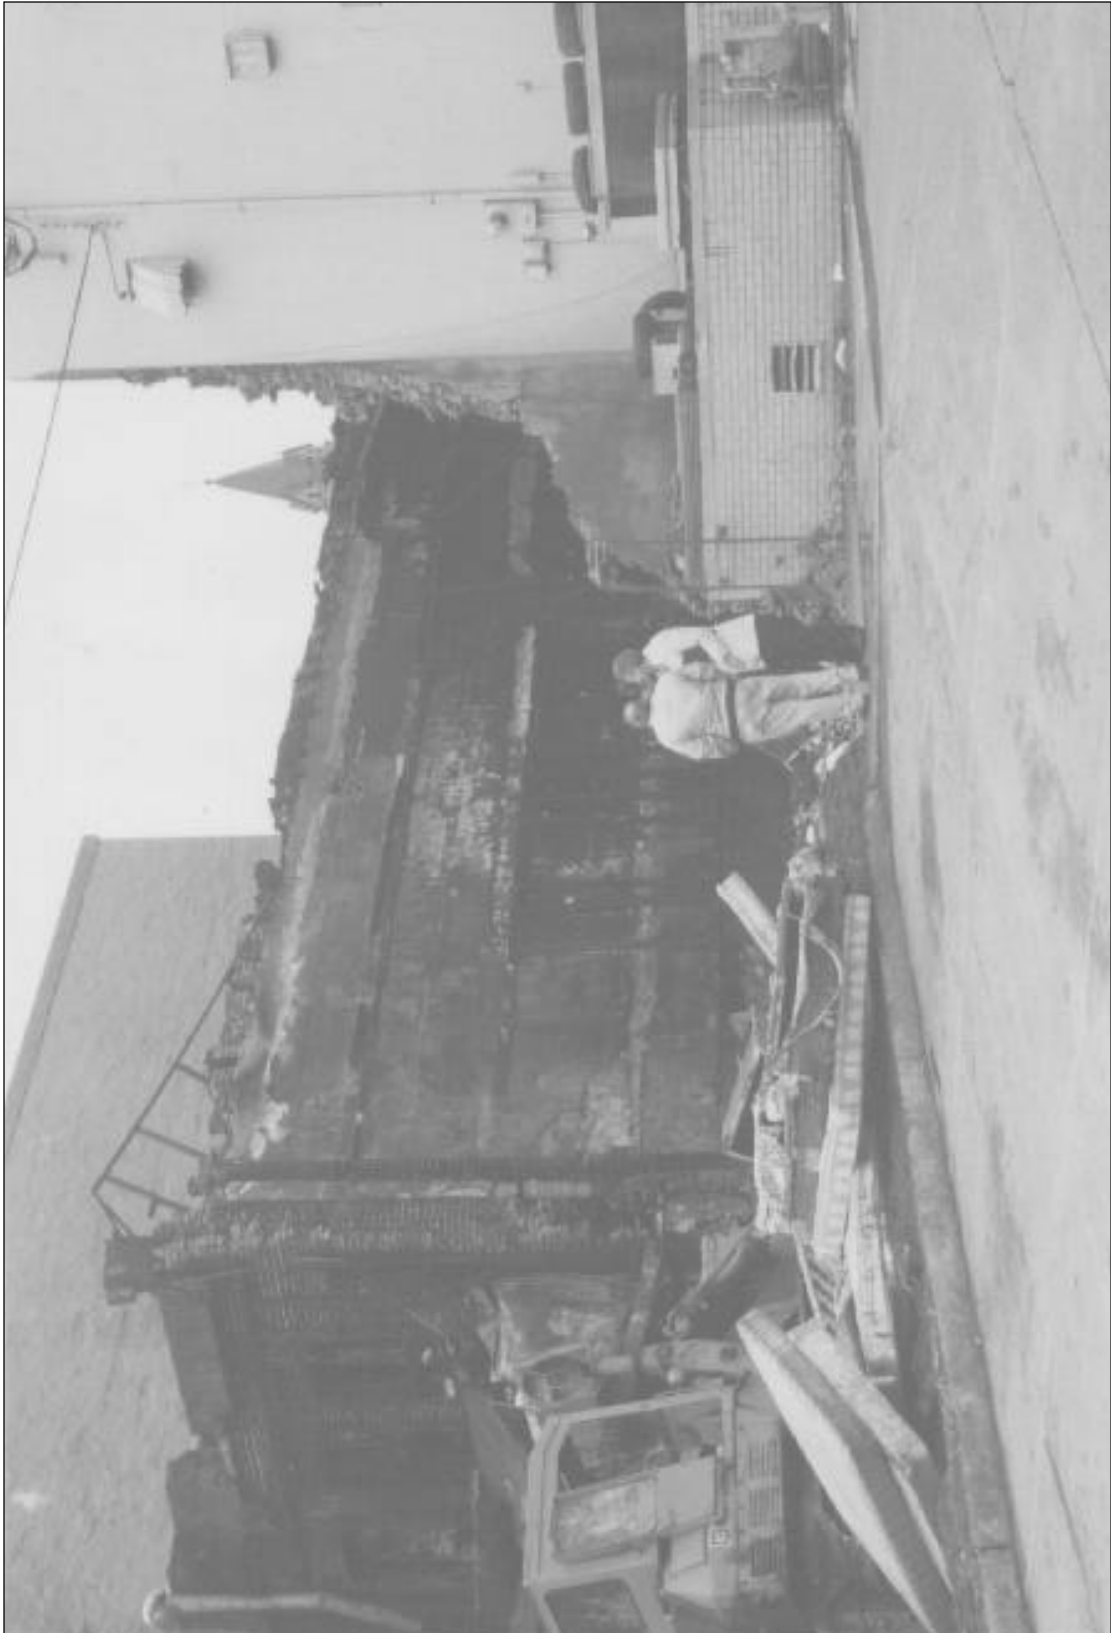
The fire was determined to have originated in the vacant area under the vision center from a fault in an electrical conduit. The power supply for the vision center was run from the rear of the building to a panel on the ground floor at the front. The wires were enclosed in conduit that was attached to the underside of the wood joists supporting the ground floor. Although the power had been shut off to the vacant part of the building, this line was still energized to supply power for the occupancy above.

The fire probably ignited one of the 3 by 10 wood floor joists and may have smoldered for hours before it was discovered. Large beams of this type have been known to burn for more than 24 hours before open flaming was observed. The electrical short could have ignited more than one joist or the fire may have spread at a slow rate in the very old wood.

The joists may also have been weakened by age and rotting, so that they could have been much weaker than one would expect from their appearance.

**View of the area of fire origin and the area where the floor collapse occurred, after most of the debris has been removed. Indentations in the brick wall indicate where floor joists were supported.**

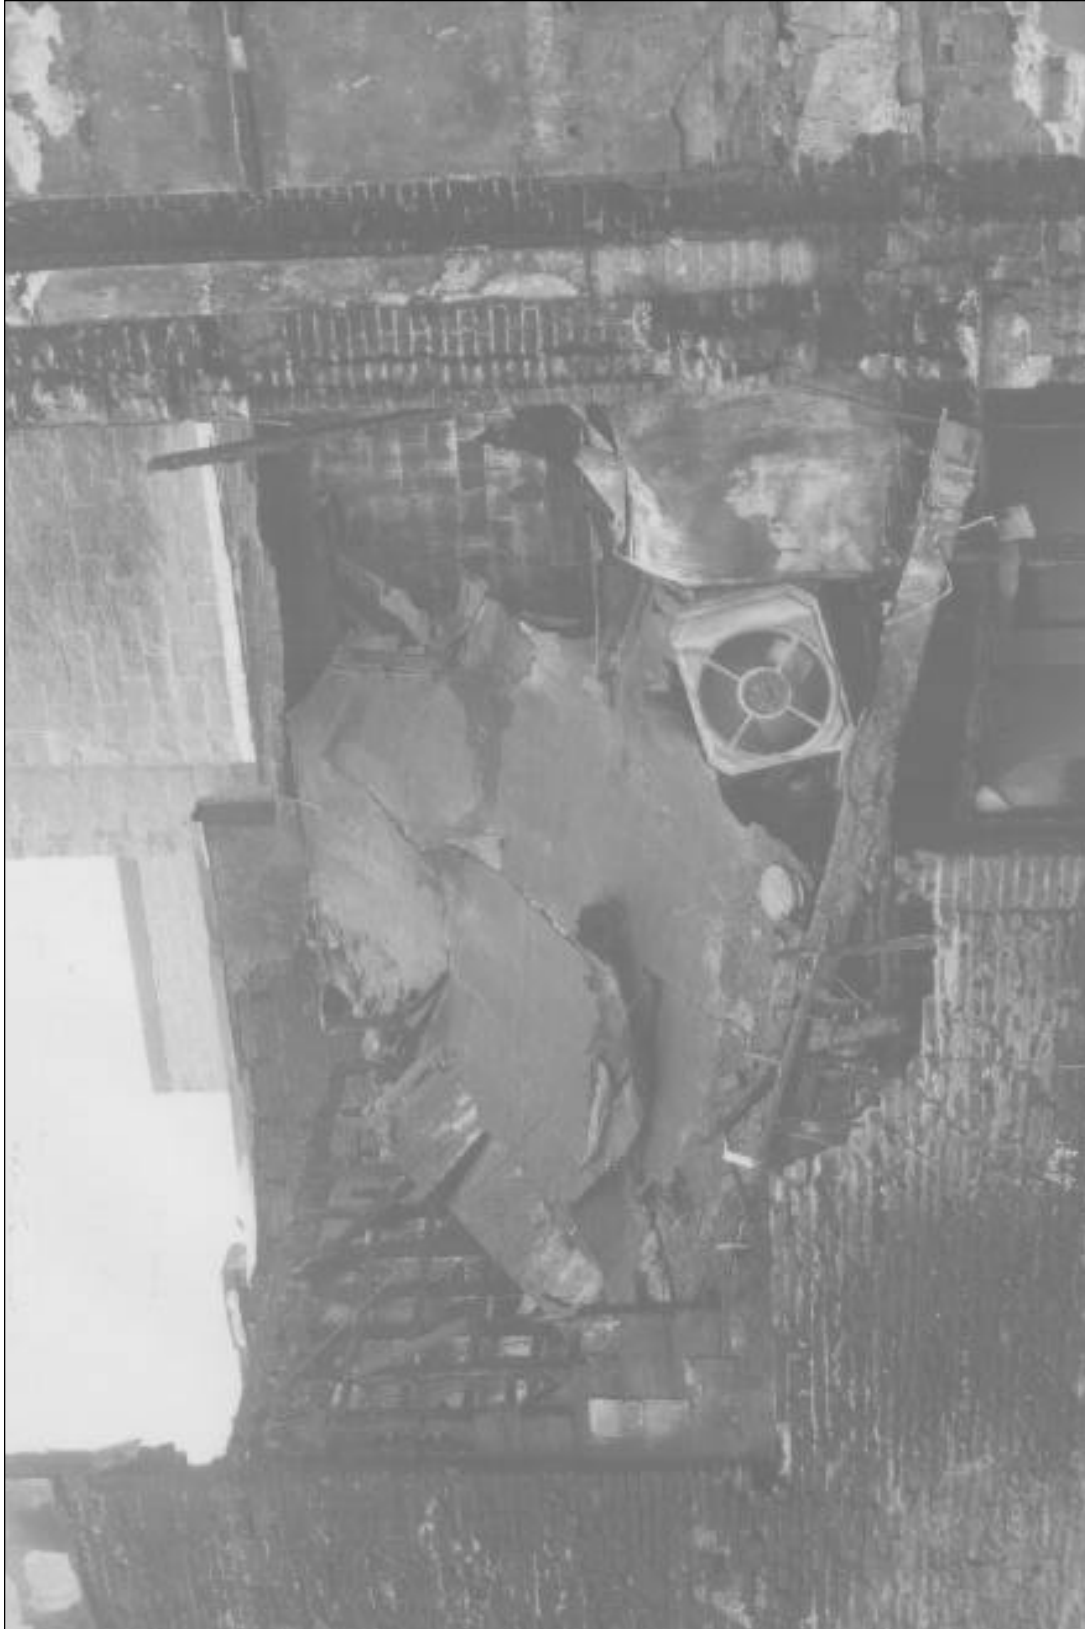
**Collapsed roof section from the mid-section of the stationery store. The original walls of the front and rear buildings can be seen in this photo. The opening at the lower level is the original alley, which was filled in by construction joining the front and rear buildings. This opening provided an open path for fire extension between occupancies.**

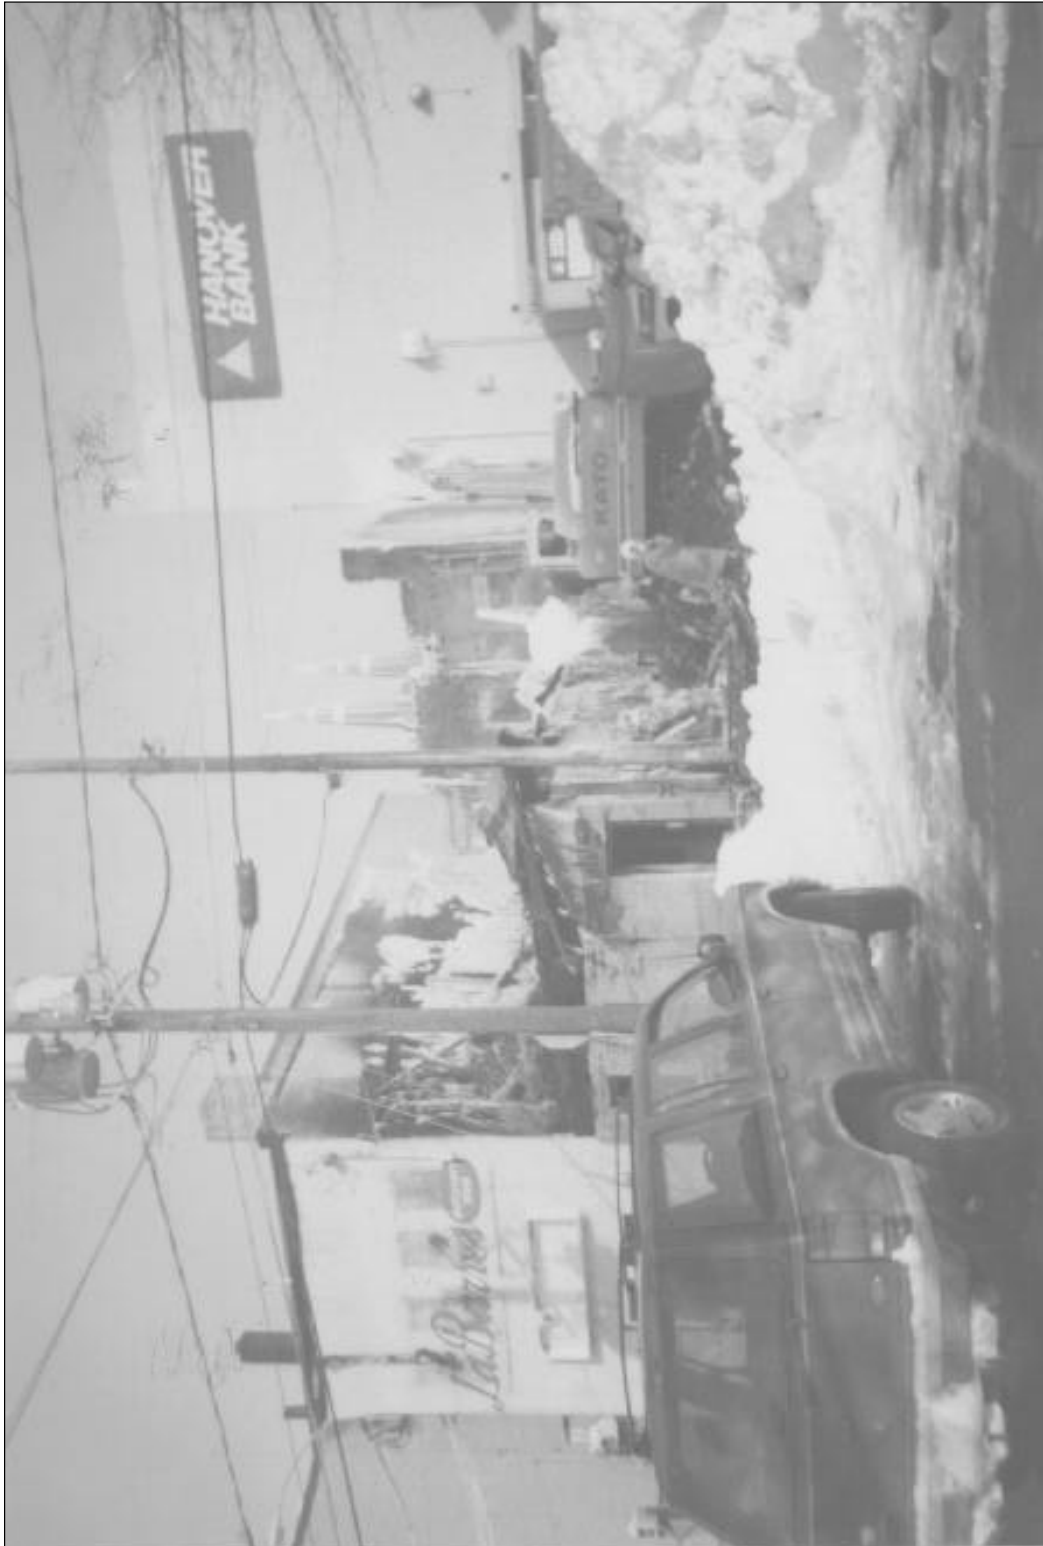
Approximately 16 hours after the fire the upper floor of the rear portion of the vision center building has collapsed and heavy equipment has been moved into the bank parking lot to begin debris removal. The door in the single story section that remains standing was the access to the vacant office occupancy. The rear wall of the front section of the building is also visible.
