U.S. Fire Administration/Technical Report Series

# Floor Collapse Claims Two Firefighters

Pittston, Pennsylvania

USFA-TR-073/March 1993

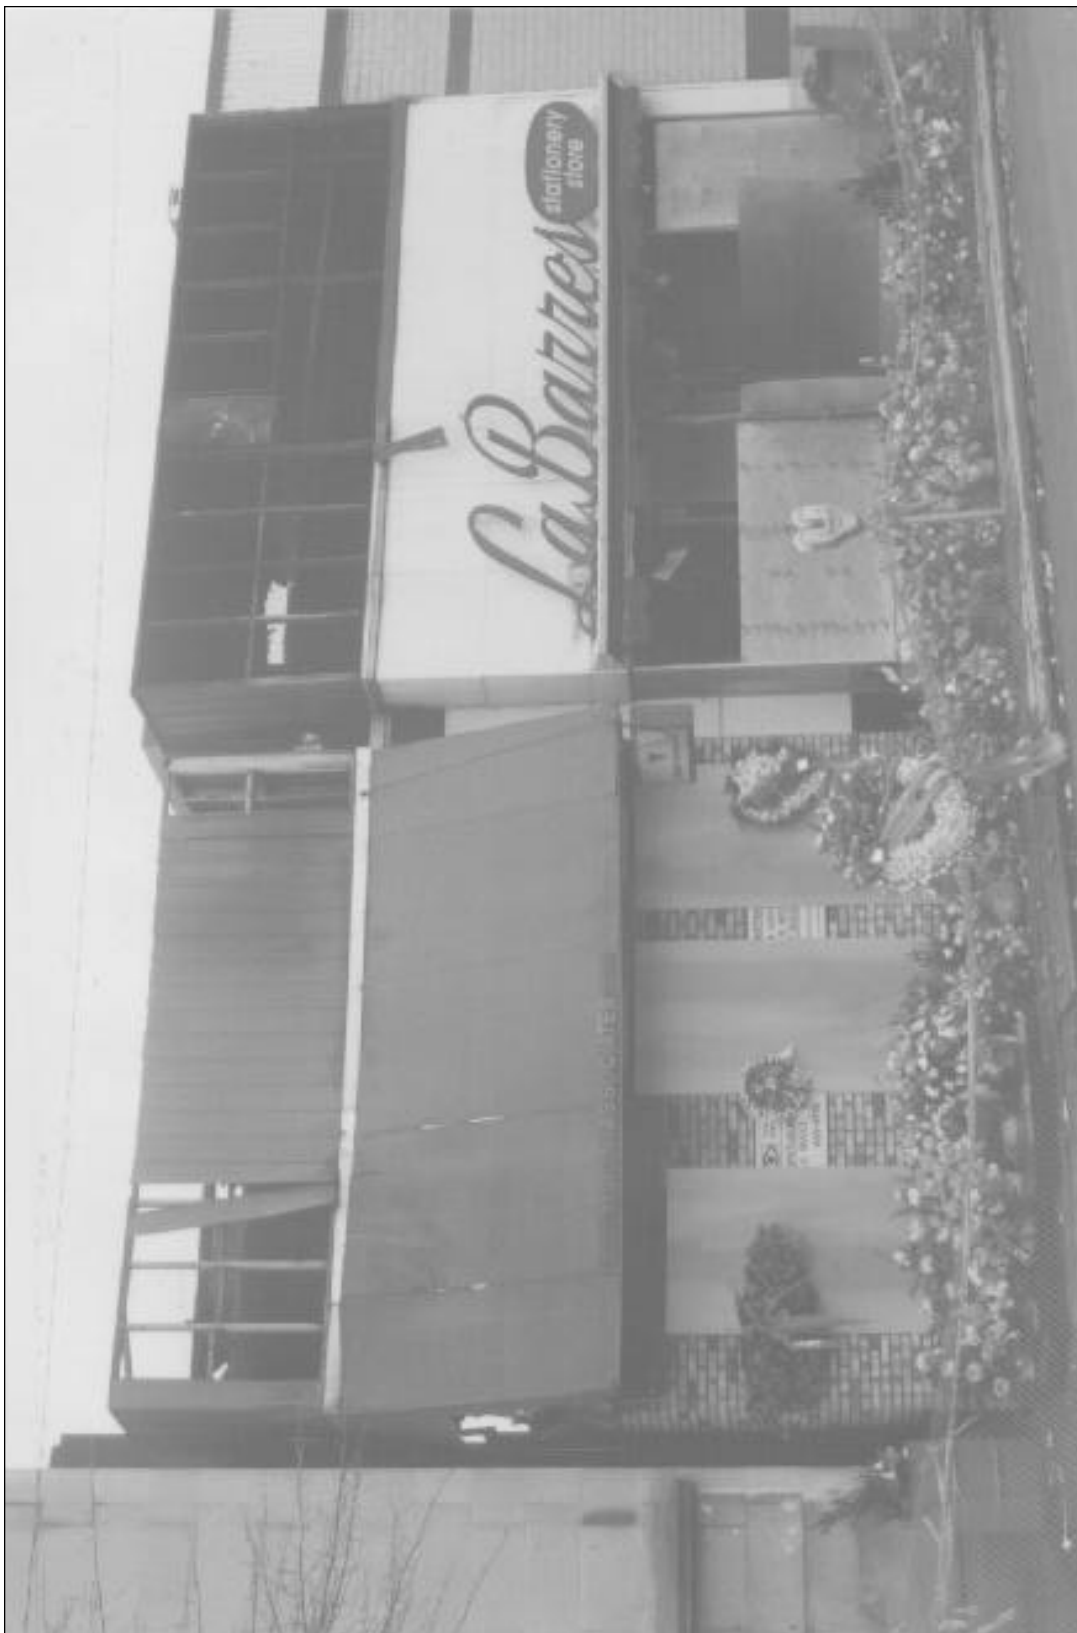
Several days after the fire, hundreds of floral tributes to the fallen firefighters have been placed on the sidewalk in front of the fire buildings.

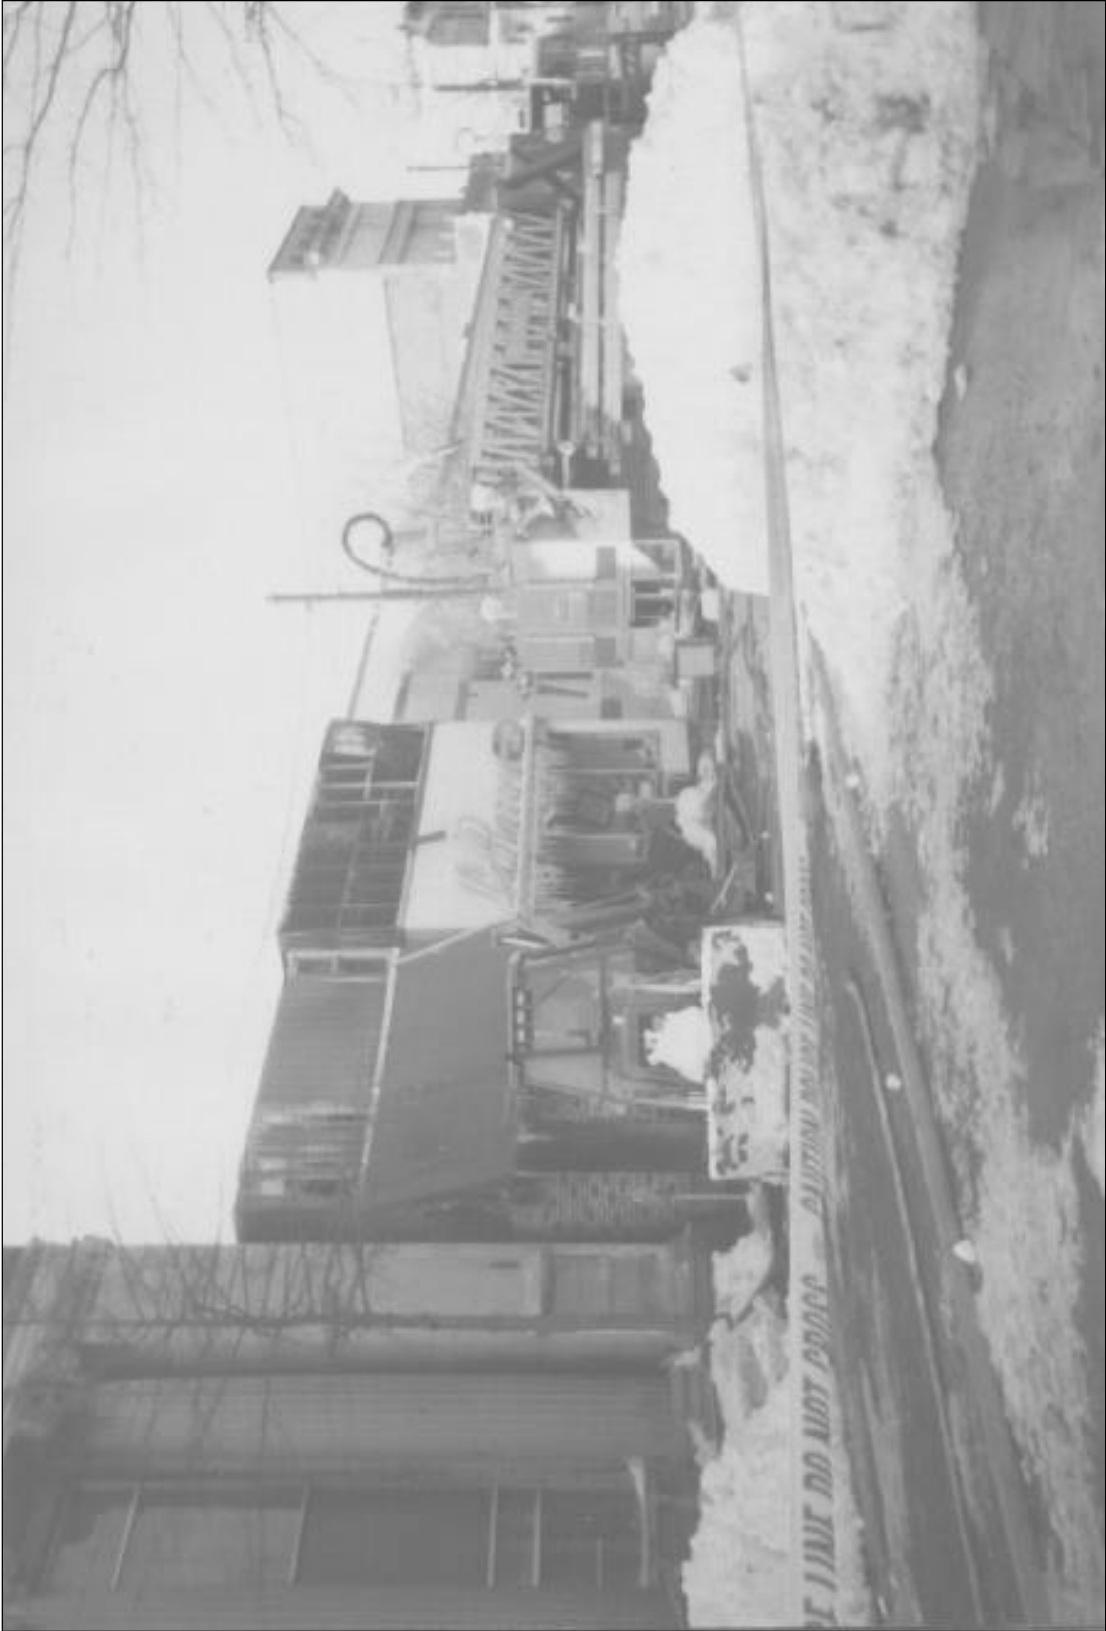
Approximately 16 hours after the fire, a backhoe is in front of the occupancy of fire origin to open an access to the coal bin under the sidewalk and provide access to the basement.
